Installation of Main Firmware

Installation of Bar Code Firmware Options

Installation of Coax and Twinax Firmware Options

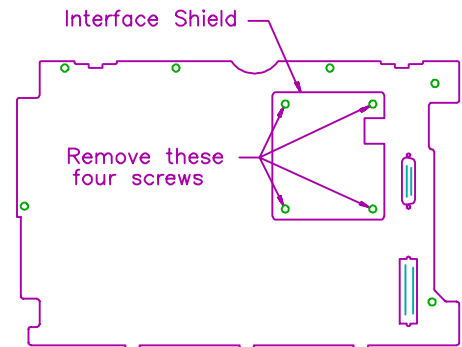
1. Turn printer power off and unplug from power source.
2. Remove the four (4) screws that attach the interface board shield to the printer rear panel.
3. Remove the firmware from the interface board and replace with the new firmware.

Be sure that the notch in the prom matches the notch in the silkscreen on the board. Failure to do so may result in damage to the prom or the board.

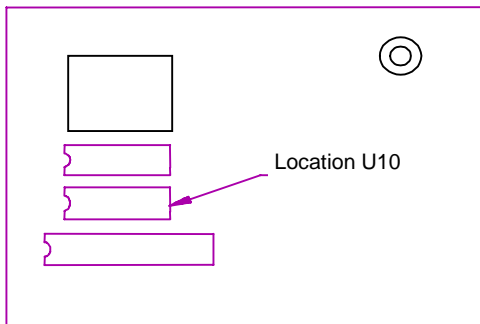
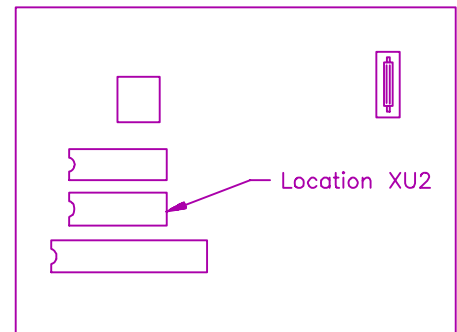
For Coax replace U10
